Torsten Fischer of Krieg + Fischer Ingenieure discusses an accident investigation involving a broken mixer in a digester tank at a biogas plant in Germany

# First-person sleuthing, broken mixer in digester tank

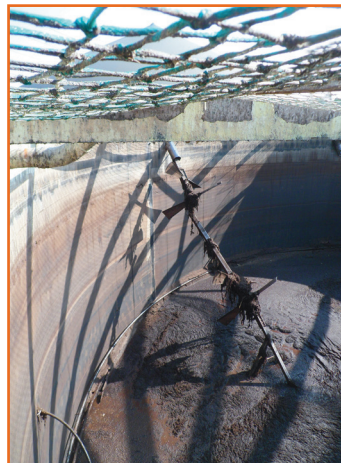
Figure 1a

happened to be two site visits. The first one was for the inventory. Figures 1a and b show the situation when

the mixer appeared during emptying of the digester tank. The second site visit was done when the broken mixer parts had already been removed from the tank, cleaned and placed nearby (Figure 2).

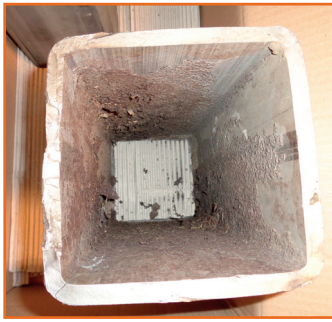
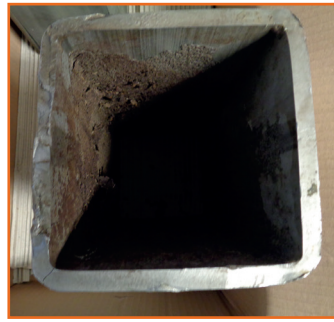
The shaft on its own is a square-type tube with one welded seam. The shaft break was just below the second propeller roughly in the middle of the shaft. This is the place where there is the biggest bending moment, when you take the shaft as a beam placed on two supports (wall and bearing at tank bottom). The propellers induce a point load into the shaft at the very position they are mounted. The shaft is also loaded with a torsion moment. All three loads interact and must be added for the structural calculation of the shaft.

Figure 4 shows the break surface of the mixer shaft. In this case, the steel is a standard stainless steel SS304 (1.4301). Interestingly, there were hardly any ‘proper’ crack growth lines. The reason could be that the austenitic material on its own simply does not show the crack performance. Or, the reason for the crack is simply different. On site, it was decided to take the relevant mixer parts and send them to a lab for further investigation.

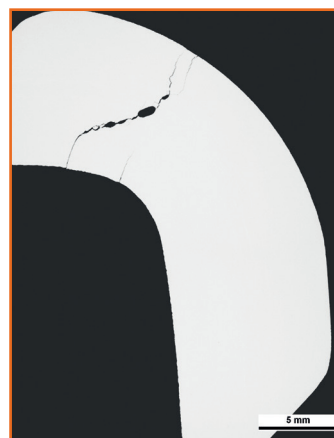
Figure 5, MPA Bremen, Germany

The lab investigation resulted in several surprises. Although a crack was visible in only one of the corners, in three of the four corners there used to be similar cracks. It was discovered that crack development happened from the inside to the outside of the corners of the pipe (Figure 5). The pipe was manufactured from a steel plate. The plate was bent and one of the corners was bent with almost no radius. The break happened to take place nearly vertical to the axis of the shaft. All three cracks ran along the direction of the axis of the shaft. The reason for the smooth break surface shows a low general force impact (low nominal strength).

Cracks in three corners of the shaft started at the inside and initially developed along the direction of the shaft. At the location of the biggest bending moment, where the force from a propeller had to be taken by the shaft, the crack also proceeded vertically until the shaft broke. The topography

of the crack surface indicated fatigue corrosion. Therefore, obviously, we have an example of a fatigue crack, based on low fatigue strength for a poorly-mounted mixer.

What could be the reason for cracks starting from inside of a square pipe? The answer is that the main force that caused the cracks originated from a deformation process: the shaft profile was continuously widened and squeezed in a 24/7 operation. In other words, during the rotation, every corner of the shaft was repeatedly slightly opened and closed. This may happen if the shaft is either not absolutely straight from the beginning or was (strongly) bent during the year-long operation. Ultimately, it started with small cracks in the corners that grew over a long period.
