Torsten Fischer of Krieg + Fischer Ingenieure discusses a legal investigation related to deficiencies of a silage plate at a biogas plant in Germany

# First-person sleuthing, investigation of a silage plate

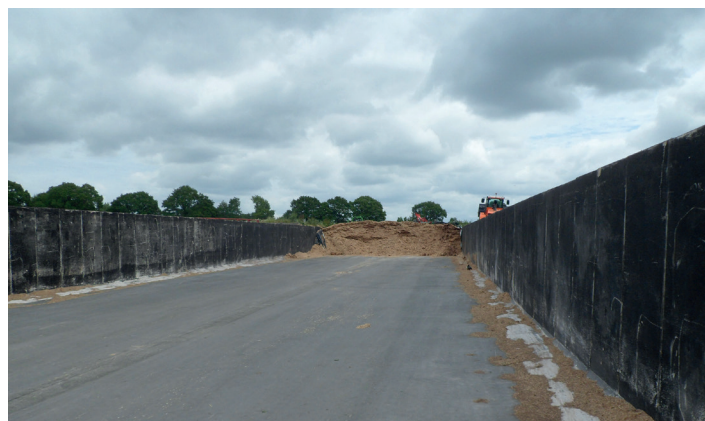
Figure 1 shows one of four chambers of the silage plate. The rest of the year’s harvest can be seen in the background. All of the silage plate’s walls were made from pre-fabricated concrete elements in the shape of an upside down ‘T’. The bottom was made from asphalt in two layers: the asphalt surface course layer and asphalt base course layer below. Figure 2 shows water/leachate on the ground, passing somehow

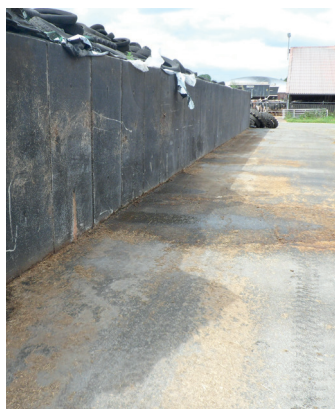
Figure 2

through the concrete elements, or underneath it from one chamber to the other. According to the operator, this first happened in 2011. Figure 3 is the most interesting. Throughout the asphalt surface there are a variety of ‘asphalt hills’; these ‘hills’ appeared during rainfall and disappeared when the weather improved. The operator had observed that some kind of liquid came out of the holes. An important question that arose from this realisation was whether the ‘hills’ meant that the asphalt was no longer

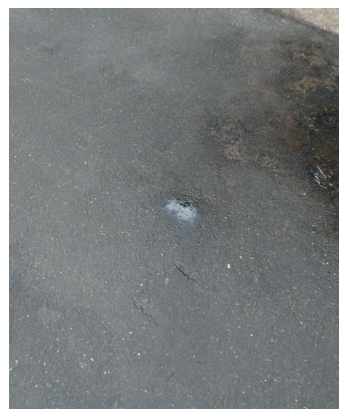
Figure 3

sealed and if groundwater pollution was possible with the leachate from the silage leaking through the destroyed surface in those ‘hill areas’.

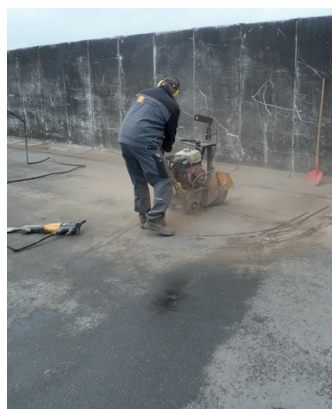
I decided to open the asphalt in four places and to remove five concrete elements. From a legal perspective this was not straightforward. When an expert witness (partly) destroys such a silage plate, who then is responsible for repairing it? The court agreed that this would not be my responsibility. Figure 4 shows how the asphalt was opened. Figure 5 shows that during the removal, there was a slight bending of the asphalt piece, which clearly shows that the asphalt was damaged and no longer stable. After removal, a yellow liquid was collected (Figure 6) from underneath the asphalt.

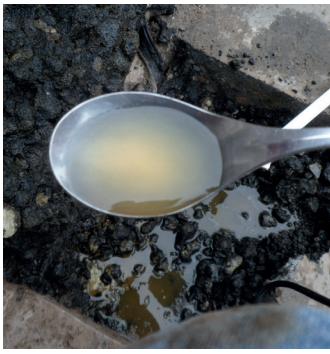
Figure 6

Later on, the laboratory investigation identified two samples from this yellow liquid as being leachate from the silage with chemical oxygen demand values of 22,100 and 46,300 mg/l. Figure 7 shows the horizontal separation of the asphalt surface and base course layers. It turned out that the base course layer was crumbling, with very limited coherence between the particles. At that time it became clear that leachate did get underneath the silage plate and that it had at least partly destroyed the

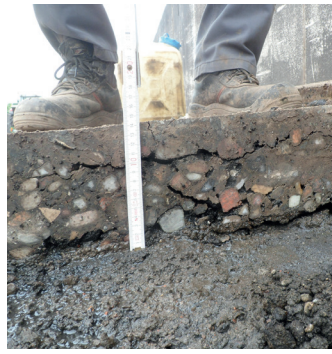
Figure 7

asphalt. In two out of three asphalt openings, leachate was found. But how could this happen if the asphalt top layer was clearly intact?

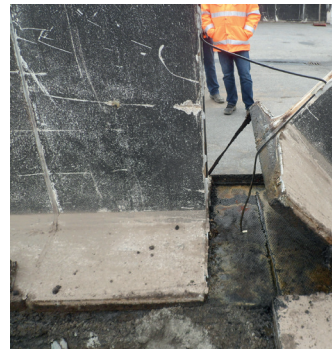
Figure 8 shows the removal of one of the concrete elements. It is important to understand how such T-elements are connected. During the assembly of the wall between the elements, a form of gum string (foam backer rod) is placed. Such gum strings can be seen hanging loose in Figure 8. Additionally, Figure 8 shows the joint between two concrete elements on the left hand side; this joint was covered with mastic (sealant). The mastic is responsible for sealing the joint. In order to prevent the mastic from flowing freely into the joint, the gum strings needed to be placed properly. This meant that those gum strings were not the basis for the tightness, but poorly-set gum strings clearly allow leakages.

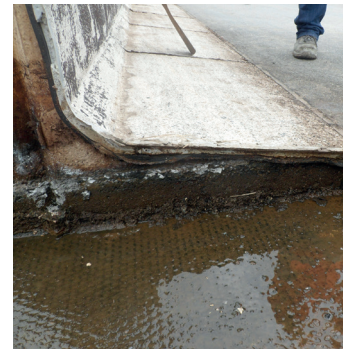
Figure 9 shows all the key elements. At the outside of the concrete element is the mastic (sealant). It is leaning towards the string. If this is not properly assembled, leachate will creep through the connection over the years and as the silage plate is filled and emptied every year, the mastic experiences wear and tear. As a result of the poor assembly during construction, I found that gum strings had been twisted and falsely positioned in several places. Underneath the concrete elements, massive amounts of leachate were found (Figure 9).

On the left hand side in Figure 9, the concrete section of the ‘T-piece’ is dark in colour. It is assumed that this shows the water/leachate level between the T-pieces.
