The author has been an expert legal witness for more than 10 years for over 120 cases and wrote his first report about a biogas plant accident more than 15 years ago. In this personal account, we learn about an investigation into an accident at a biogas plant

# First-person sleuthing, gas holder roof rupture

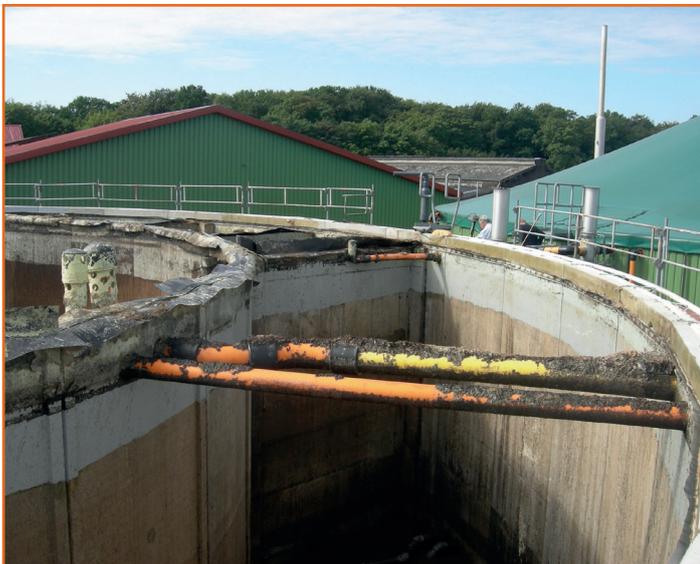
The digester tank consisted of two concrete rings and the space between the two rings was divided into

several chambers with the gas holder roof covering the entire tank diameter, Figures 1 and 3. It is not the subject of this very report to discuss different digester tank designs. However, it shows that field work for an expert witness means being confronted with a variety of different problems requiring

Figure 1: showing the space between the two rings

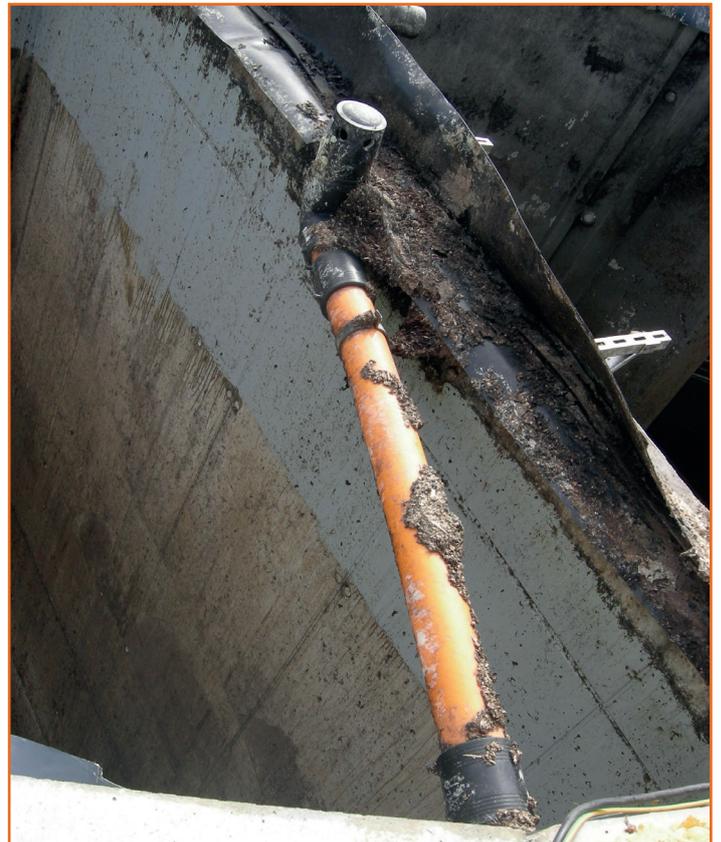
Figure 2: the outer wall

middle, between the two concrete tanks, Figure 2. This pipe was covered with

a kind of mask, preventing scum and solid particles from entering the gas pipe. These

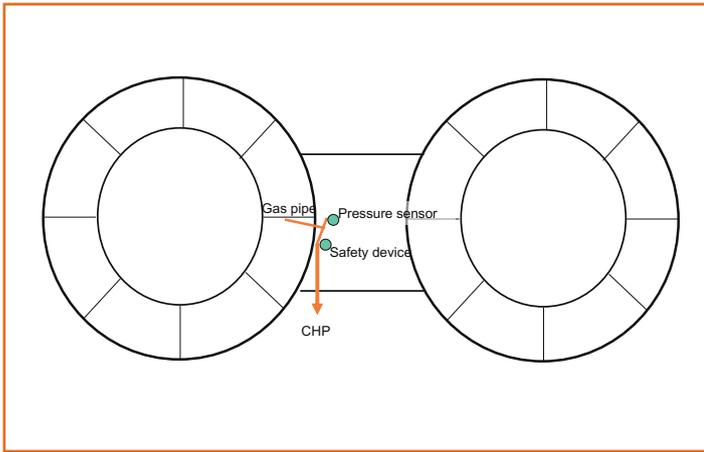
Figure 3: showing the digester-tank chambers from the top down

substrate. The chambers were used as hydrolyses or storage tanks. Maximum operational pressure of the biogas inside the gas holder was 3.5 mbar. There was an overpressure valve that was adjusted to exactly this value – in order to protect the gas holder membrane, Figures 3 and 4. A pressure sensor right in front of this safety device was used for continuously measuring the pressure inside the gas holder, Figures 3 and 4. The gas holder on its own was a kind of double-membrane gas holder. The weather membrane

three pieces, pipe length, bow and mask, ended up with a pressure loss of about 1.5 mbar for the through-flowing biogas. Neither the pressure sensor, nor the overpressure valve, was mounted directly at the tank wall. Instead the pipe coming out of the tank was split at a T-piece, Figures 3 and 4. The left arm of the T ended at the pressure sensor and the right arm at the overpressure valve.

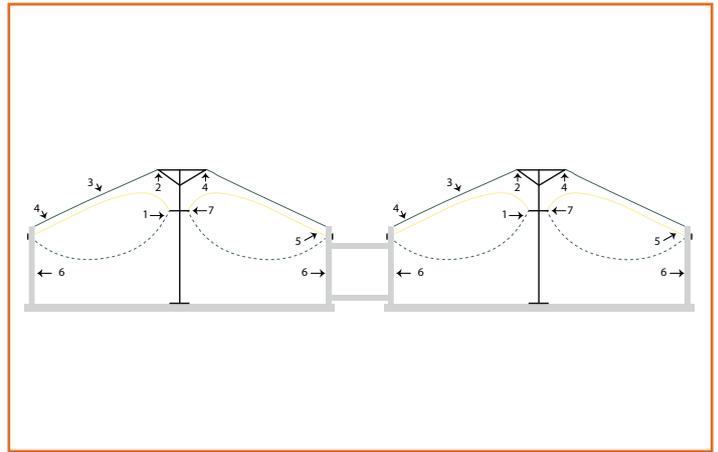
different technical solutions. In the centre of the tank was a column that was the basis for the gas holder structure, Figure 5. While the digester tank was uncovered and open, you could see the centre column had been placed next to the tank, Figure 6. The biogas plant had been in operation for 3.5 years.

Figure 5: showing a side-on view of the identical tanks

(outside) was spanned over the centre column and fixed at the outside top of the digester tank. The inner membrane – responsible for the gas holding – was fixed in a ring that was located about two thirds, up from the bottom of the centre column, Figures 5 and 6.

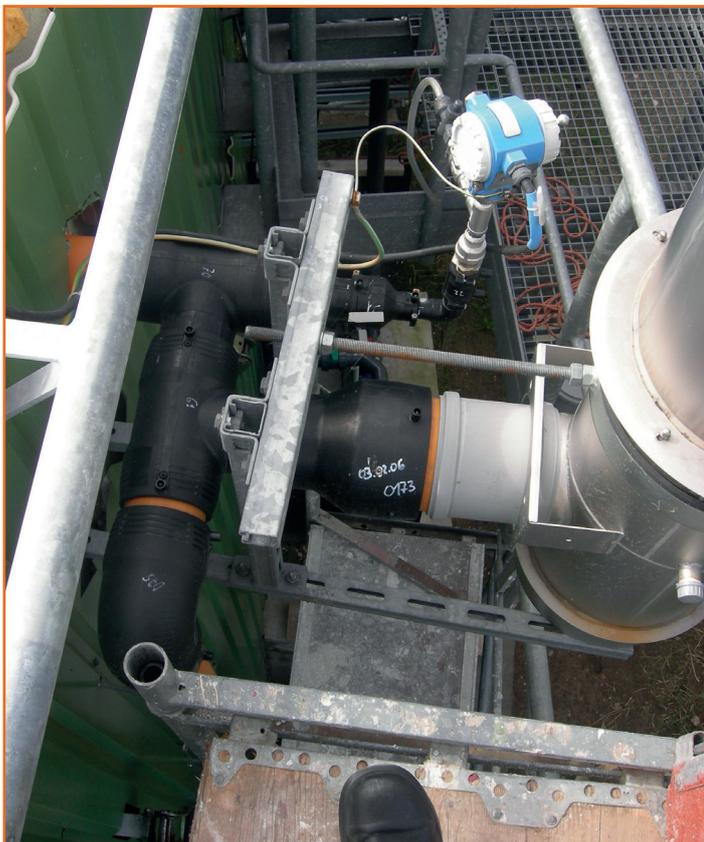
overpressure valve not work? I disassembled the valve on site, in order to check the workings. But nothing came of it, the pressure sensor checked out fine. Nothing. And why was the roof on top of the neighbouring digester operating perfectly? With so little difference between the two, the reason for the accident was no clearer.

Figure 4: showing the overpressure valve

a few changes were to be done to fix the overpressure valve directly at the digester tank wall, the main expense was due to the emptying of the digester tank and the loss of its gas production.

There is a reason why standard safety regulations require overpressure valves to be fixed directly at the tank surface. This way, pressure losses can be minimised. It is an absolute no-go to extend such biogas exit pipes into the digester tank without strict control of the pressure situation. Even the smallest pressure losses in line end up with — potentially — a risk for the plant operation. Operators need to understand their gas system.

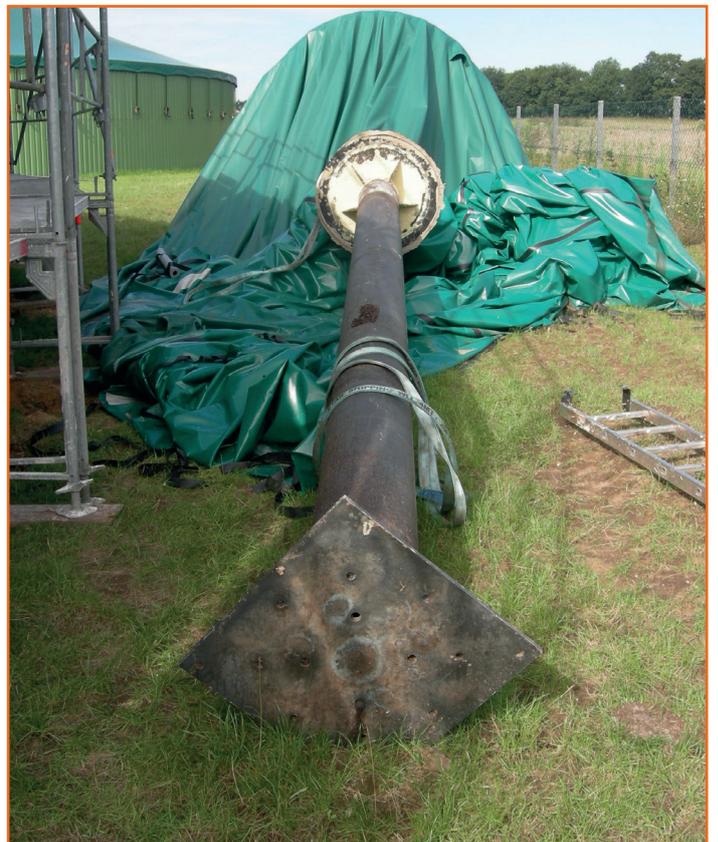
Figure 6: showing the centre column

The final evidence came from checking the membrane fix point at the centre column, Figures 6 and 8. The original fixture involved drilling round holes into the membrane and these holes were widened, radially, and over time – an operating time of about 3.5 years – the holes grew too large.

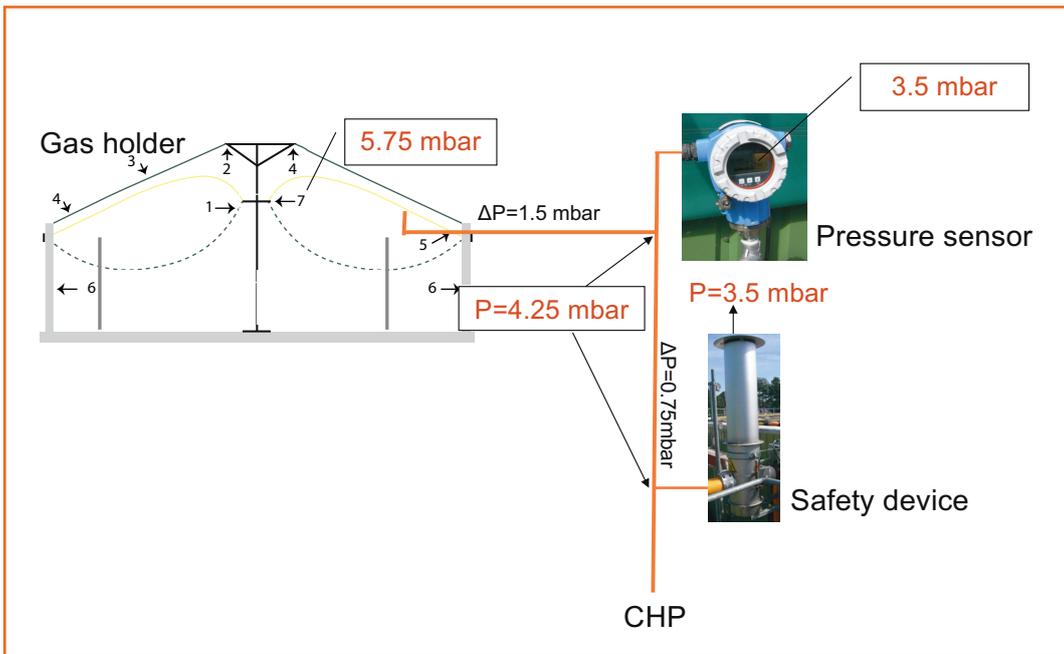
Figure 7: showing the pressure loss and resulting display

On the way to the overpressure valve there was another pressure loss of about 0.75 mbar, and the resulting display on the pressure sensor showed 3.5 mbar, but inside the digester tank it was actually 5.75 mbar (assuming no pressure loss, because of the very short distance, for the left arm of the T), Figure 7. In other words: at the moment the overpressure

valve opens the real pressure inside the digester tank was 5.75 mbar. The question was: what pressure could the inner membrane stand?

While the operator intended the digester tank to run at a maximum 3.5 mbar, the real pressure in the tank was, very likely, anything up to 5.75 mbar.

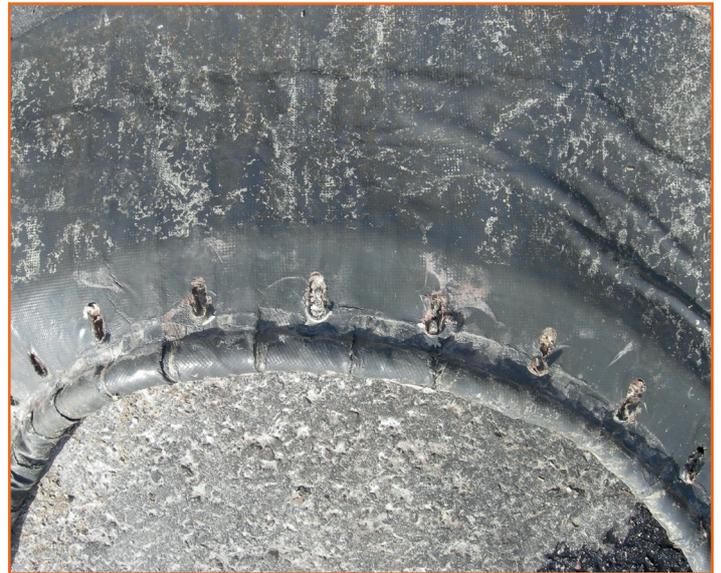
Those long holes indicate too much stress having been loaded upon the inner membrane, call it a micro rupture; it's a sign that the membrane couldn't withstand the forces being applied.

It can be assumed that the inner membrane was designed for about 5 mbar maximum pressure. Over an operational period of 3.5 years, the inner membrane was stressed to its limits repeatedly. This could

be shown 1., mechanically, with the long holes where the bolts hold the membrane at the centre column, Figure 8, and 2., by the values recorded in the process control system, ongoing stress gradually widened the holes.

Figure 8: showing the widened membrane holes

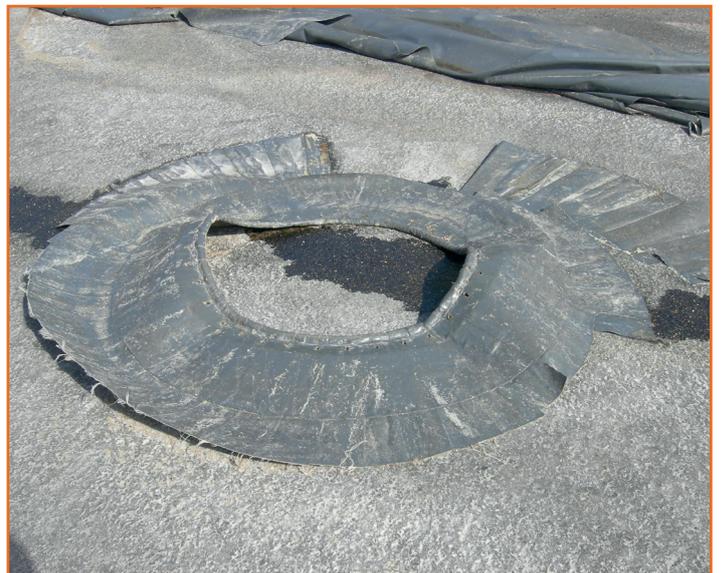
It is interesting that none of the holes started the rupture, but instead the rupture started outside of the ring, at a distance of about 20 cm, Figure 9. This could be observed when the membrane

The rupture happened because the membrane was folded around the big hole for the centre column and, therefore, had twice its strength. The tension became too much close for the area where the overlapping ended. There, the crack started.

Figure 9: showing the holes causing the rupture

While the inner membrane needed to be replaced and
