#### Preventing Accidents in Biogas Plants - Experience of an Expert Witness for Biogas Plants -

Torsten Fischer and Dr Katharina Backes

> London, Ontario March 10, 2010

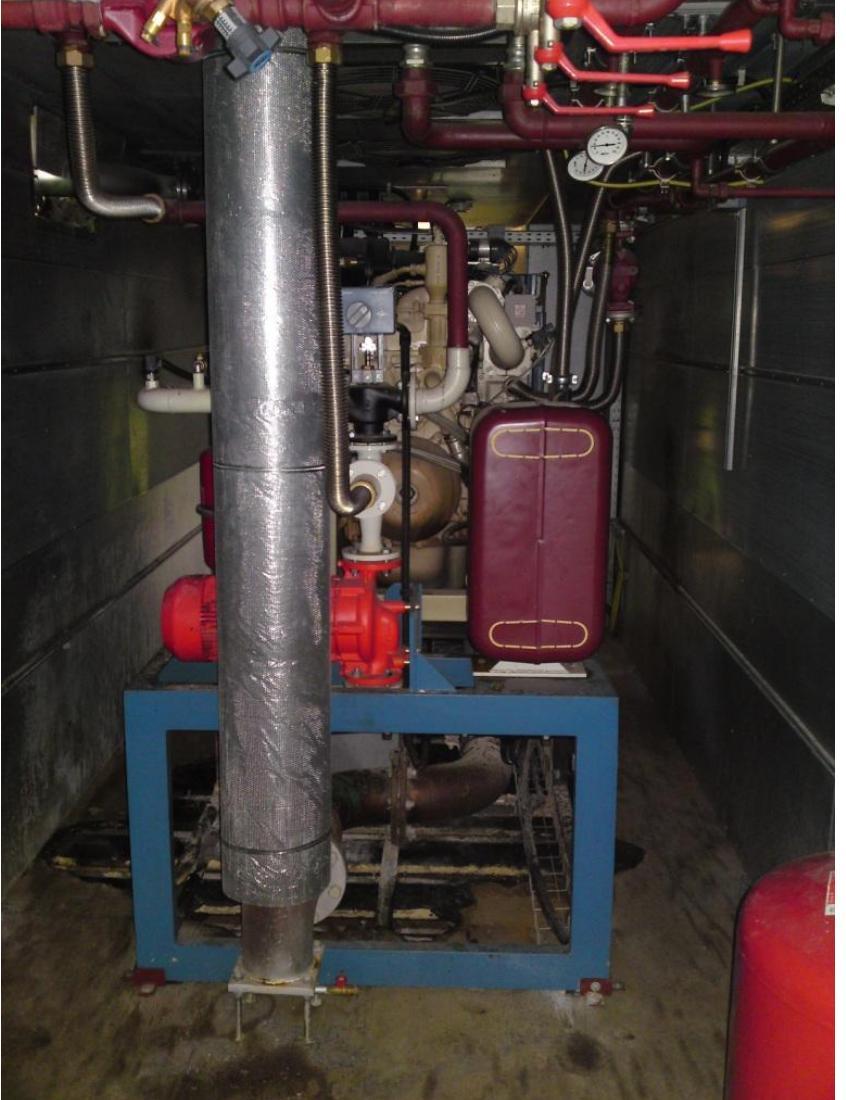
The CHP-Container had a Timber Flooring.

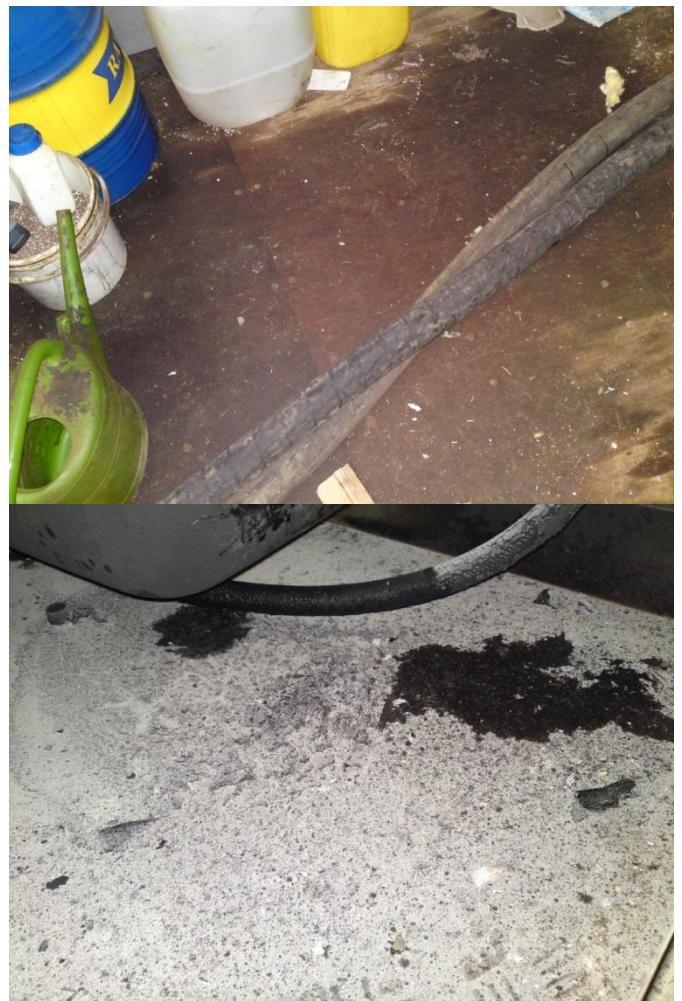
Floor was contaminated with Oil Residues and Lube Oil.

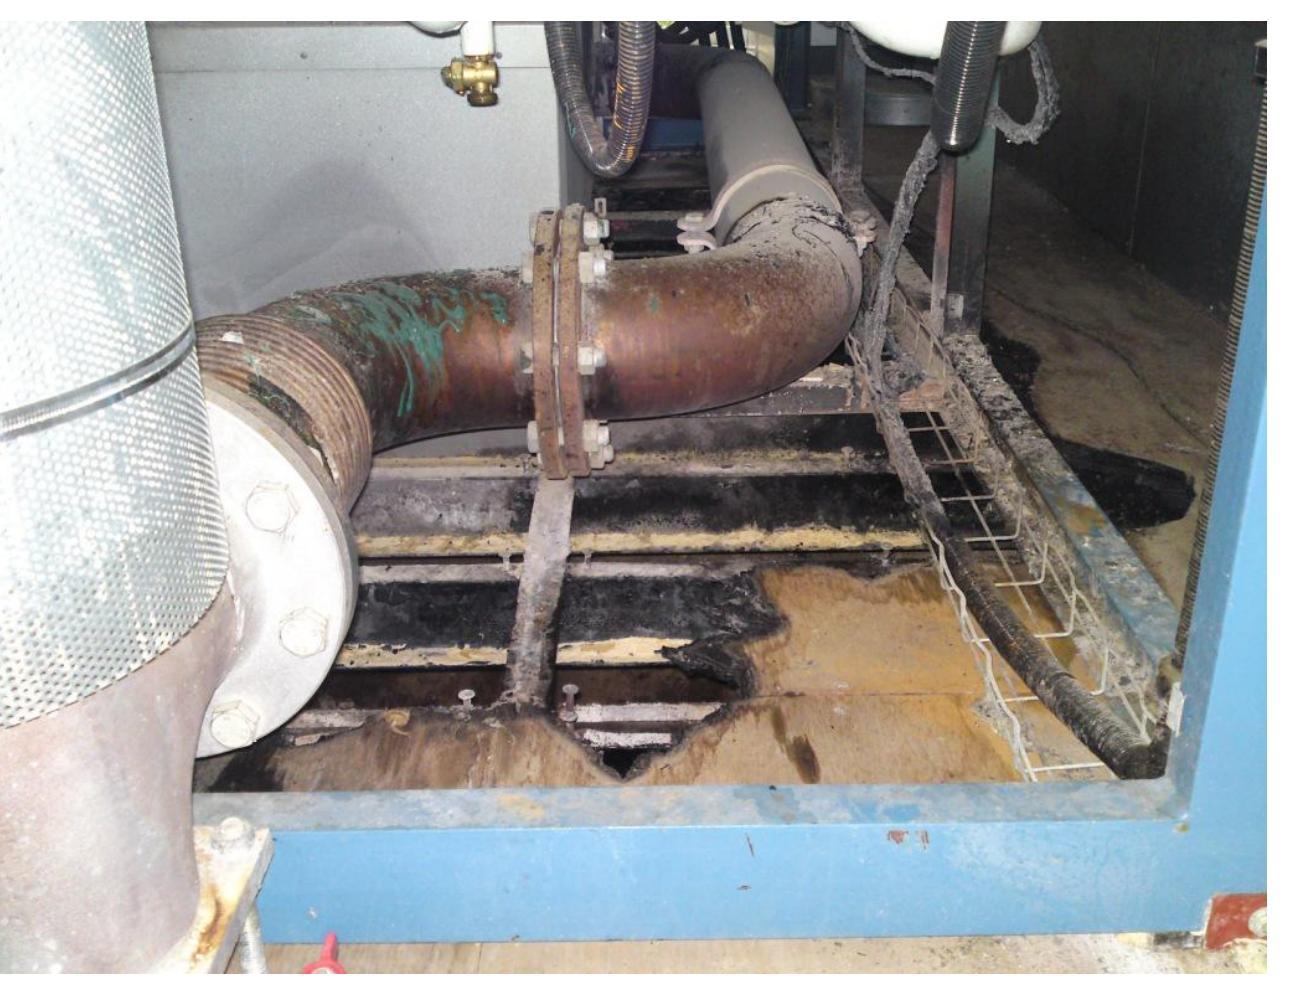
Hot Exhaust Pipe was set up with little Distance to Timber Flooring.

→ Timber Flooring dried
 up
 → Dried Timber Flooring
 ignited and carbonized

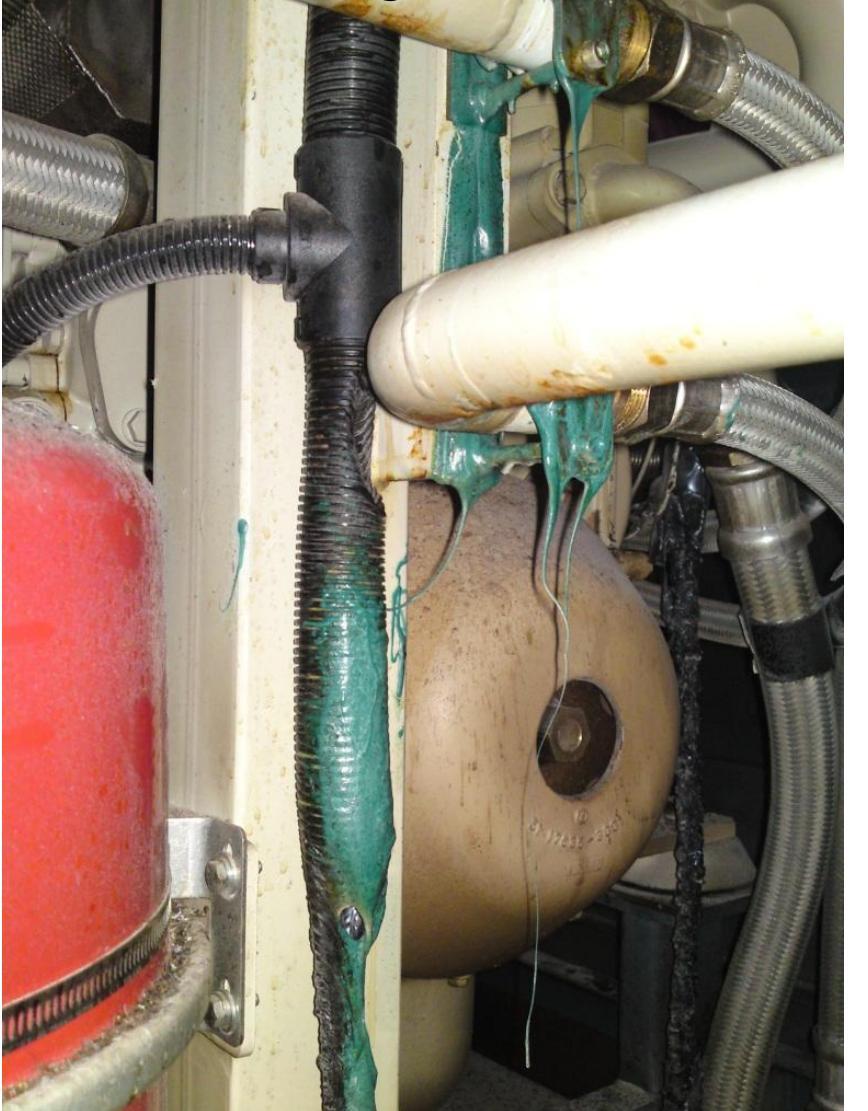
Caused by increasing Temperature the Plastics of the Cable Insulation and Holders melted and dripped off.

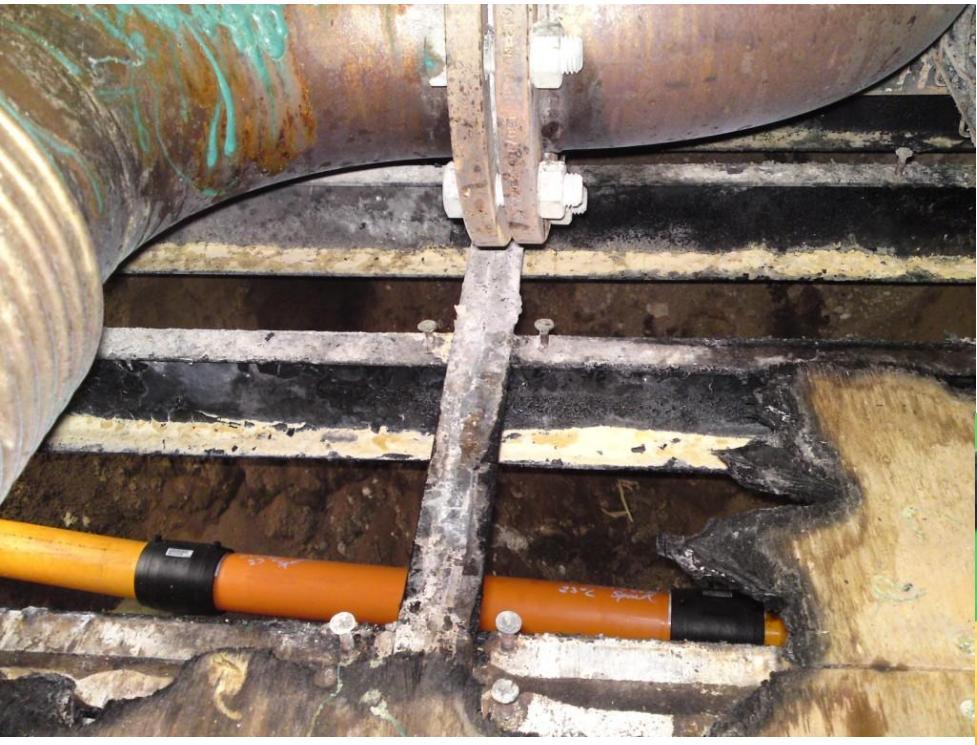
Melted Plastic dropped down on PE-Biogas Pipe underneath Container.

- $\rightarrow$  Pipe melted
- $\rightarrow$  causing Holes in Biogas Pipe

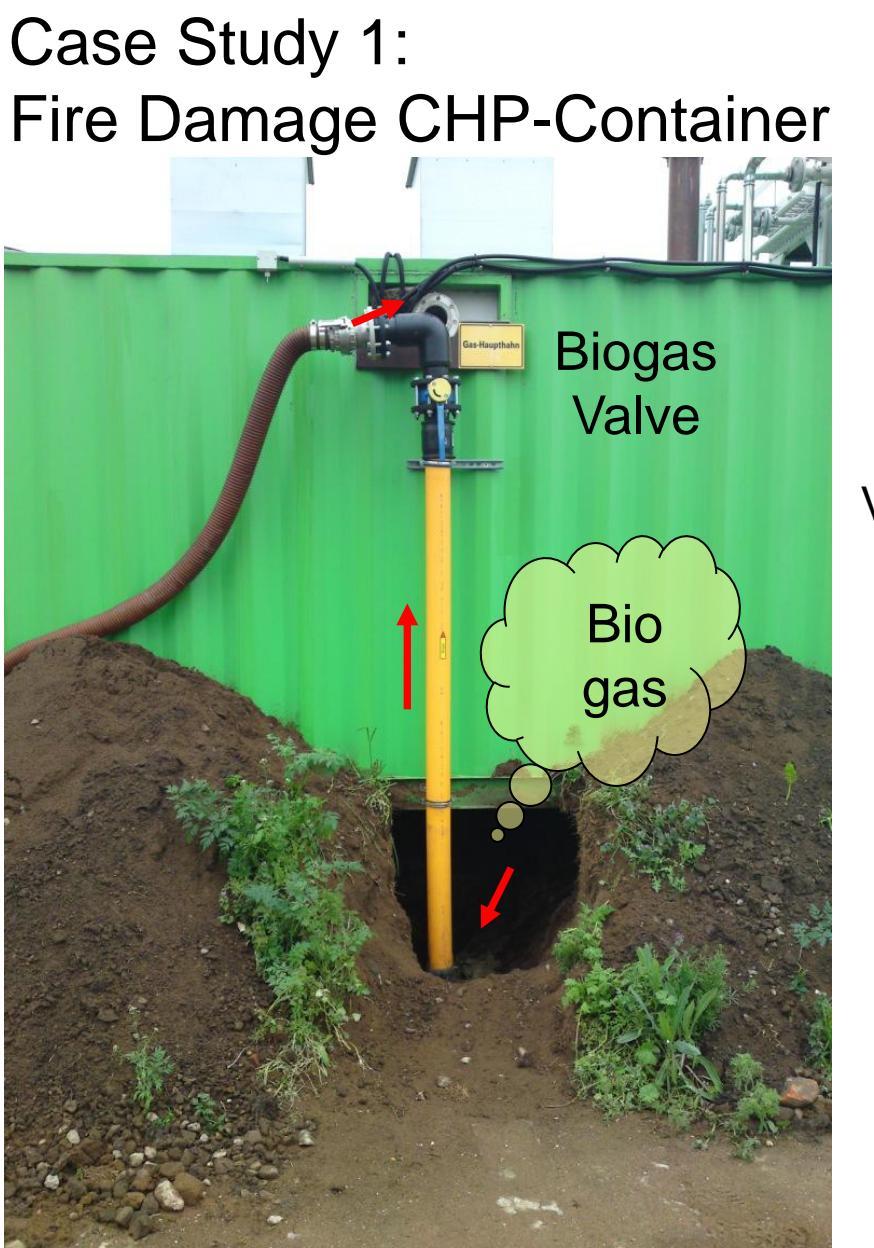
Operator closed the wrong Biogas Valve

→Biogas still escaped overnight from Hole in the Pipe

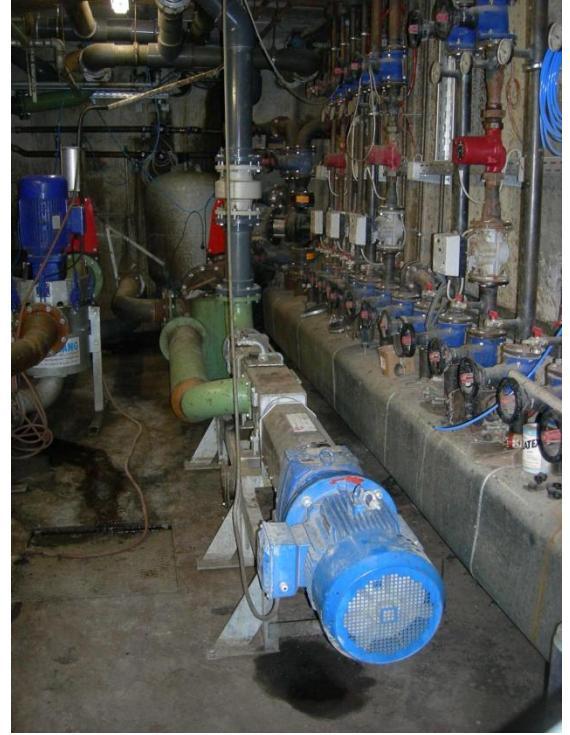
The screw pump was not equipped with a pressure sensor on the pressure side of the pump or a protection against dry running.  $\rightarrow$  The pump could only be stopped manually.

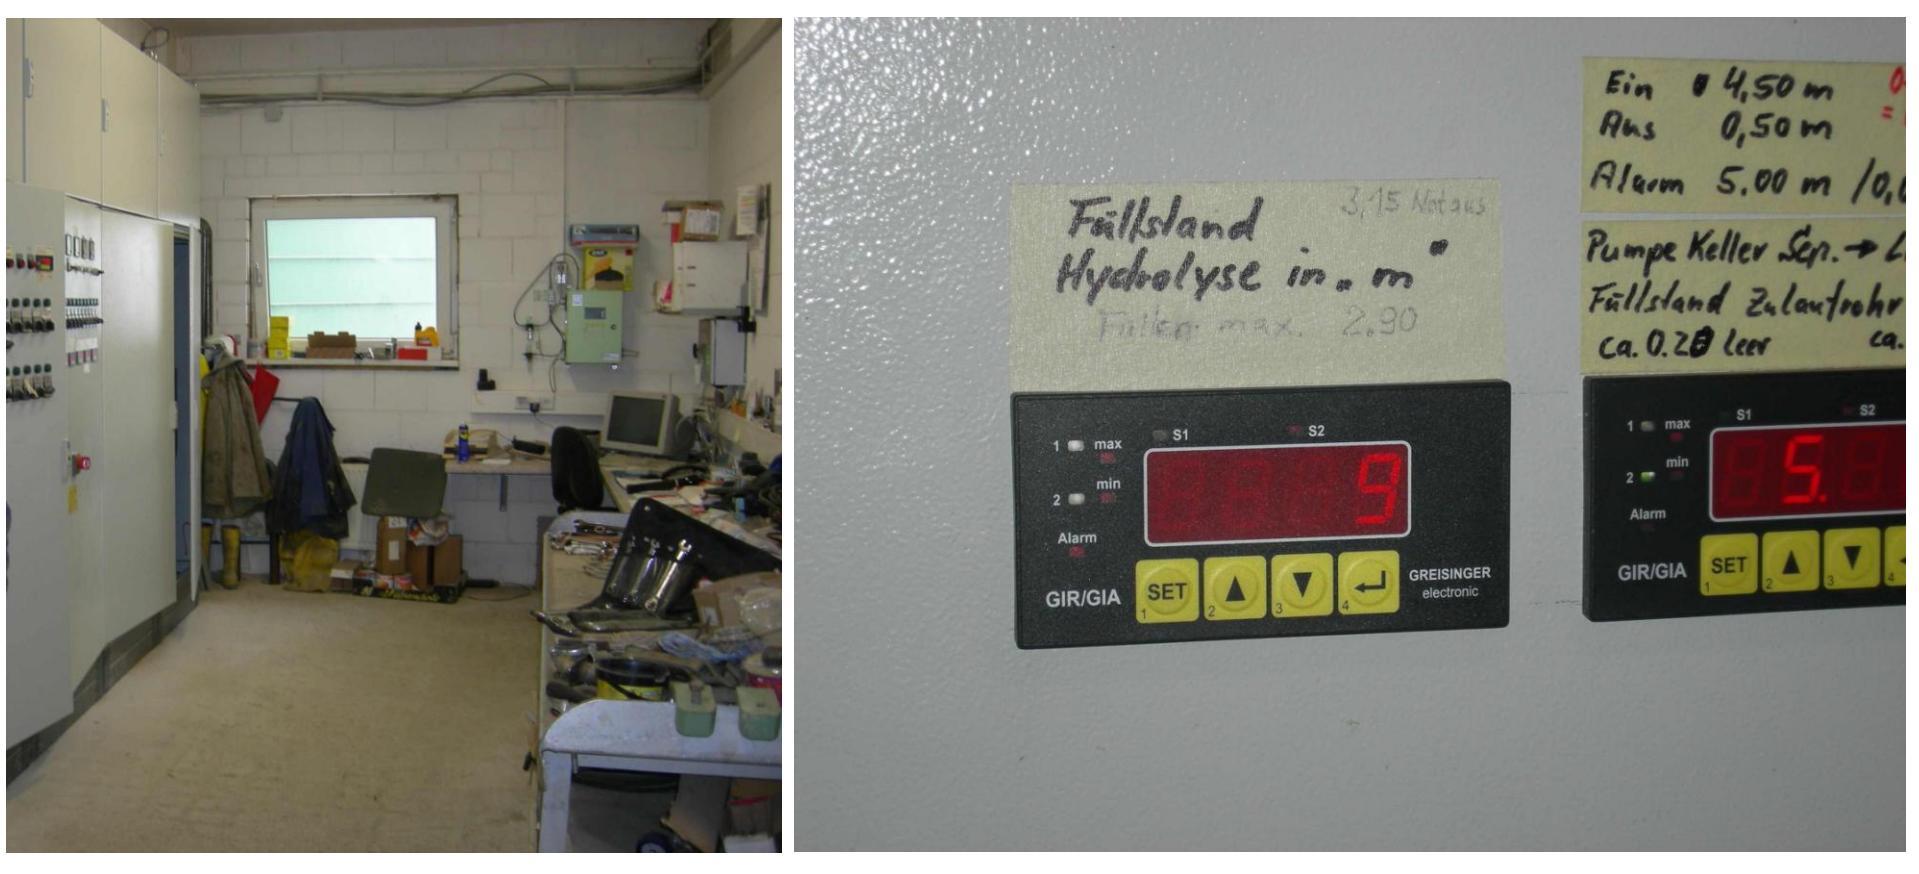
If the maximum filling level of the tank is reached a warning massage is sent to the cell phone of the operator. He switches off the pump manually.

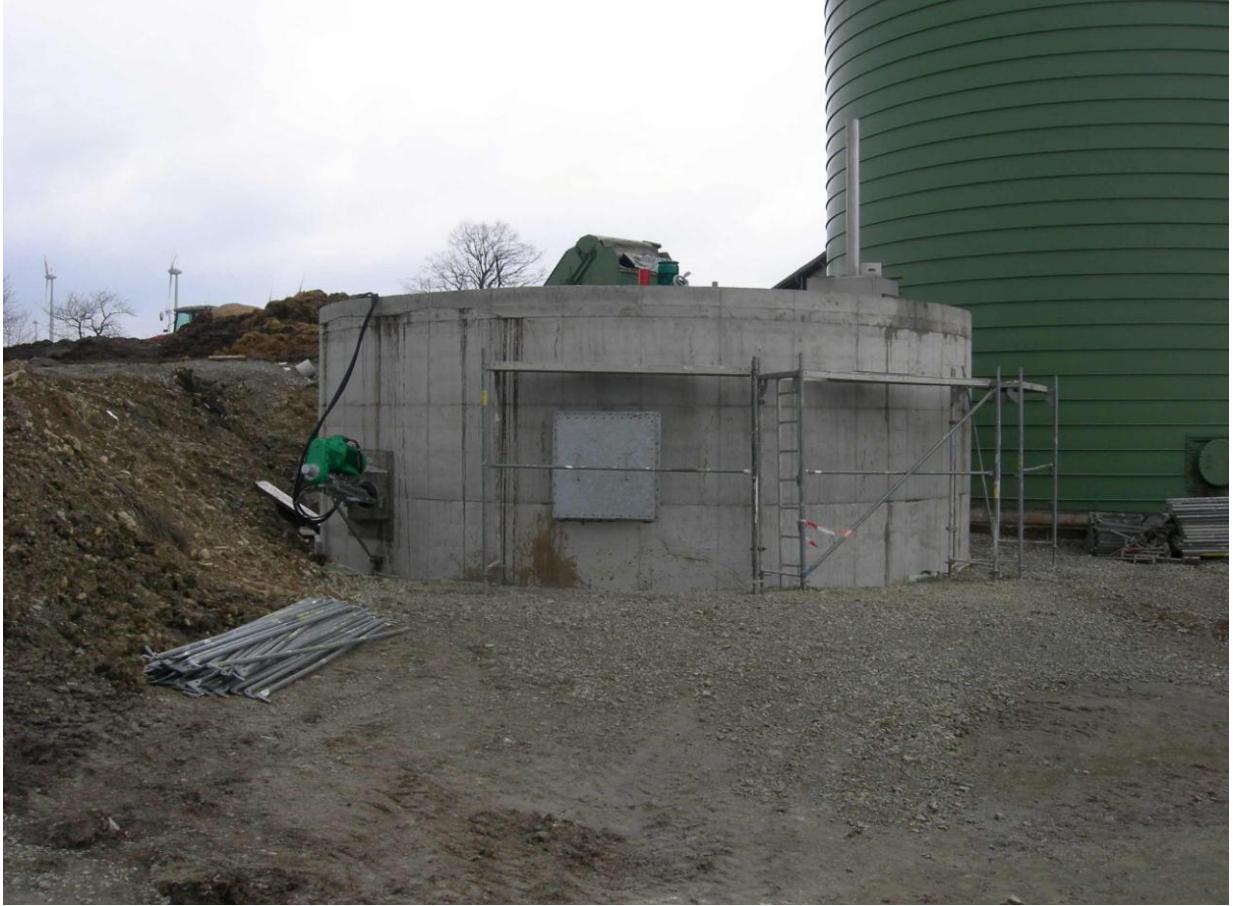
At the day of the accident the operator forgot his cell phone. The pump continued pumping manure into the tank...

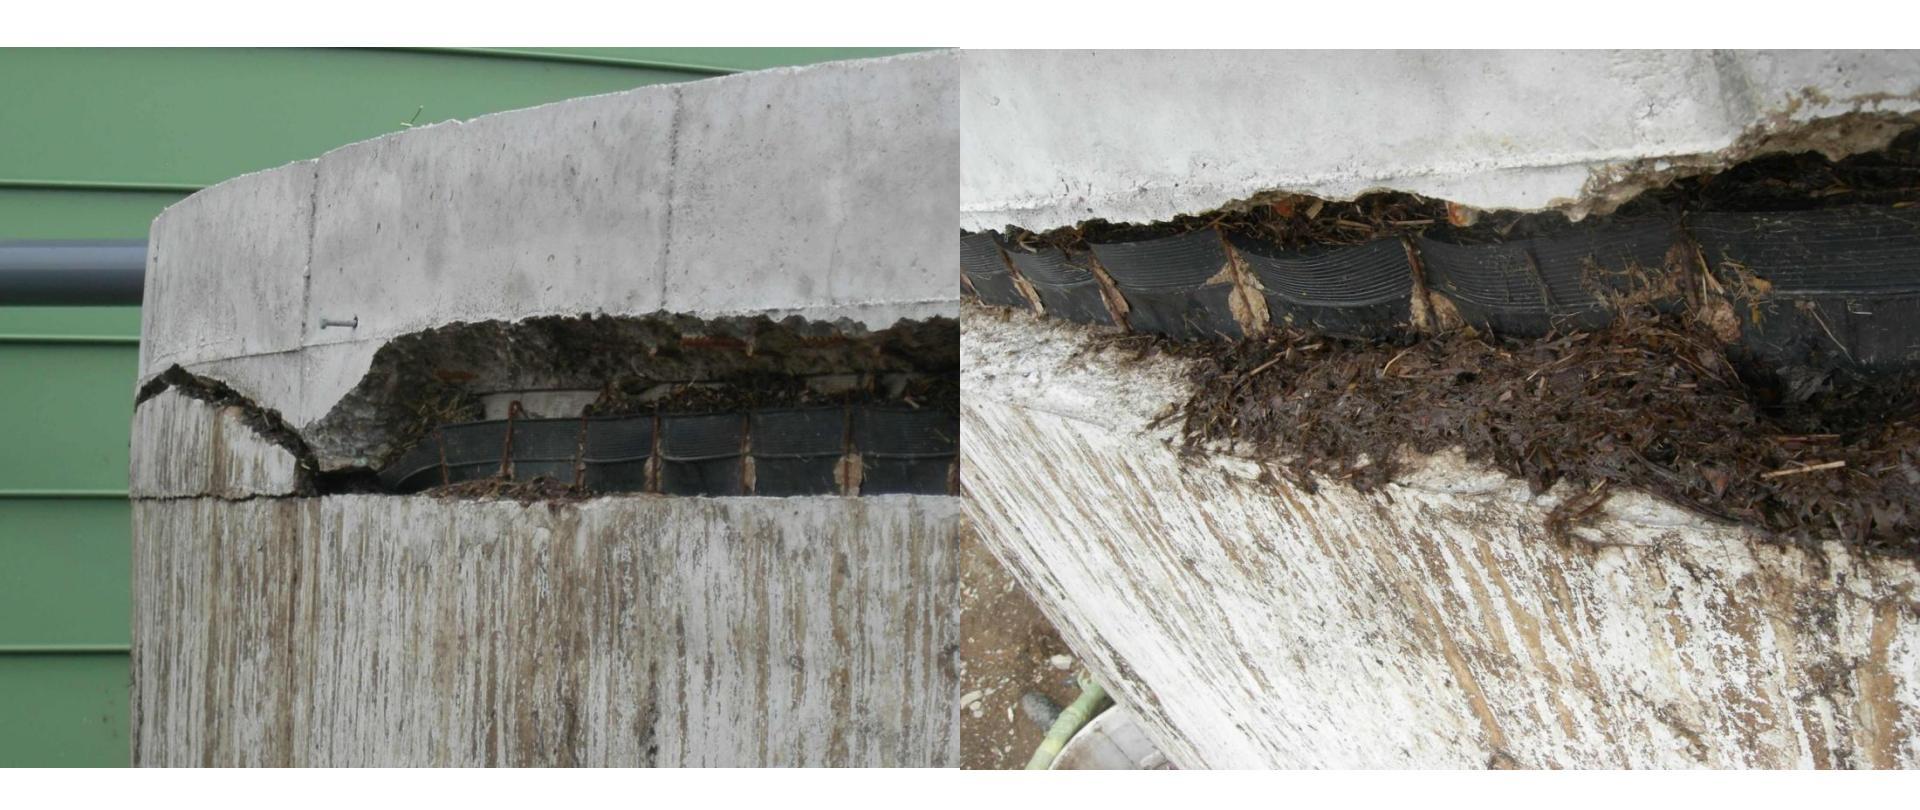
...until the cover of the hydrolysis tank had been pushed up by the fluid pressure and blasted from the tank.
