Common deficiencies in biogas plants and lessons learned

Torsten Fischer

Brussels
July, 06th, 2022

“Common deficiencies in biogas plants and lessons learned“

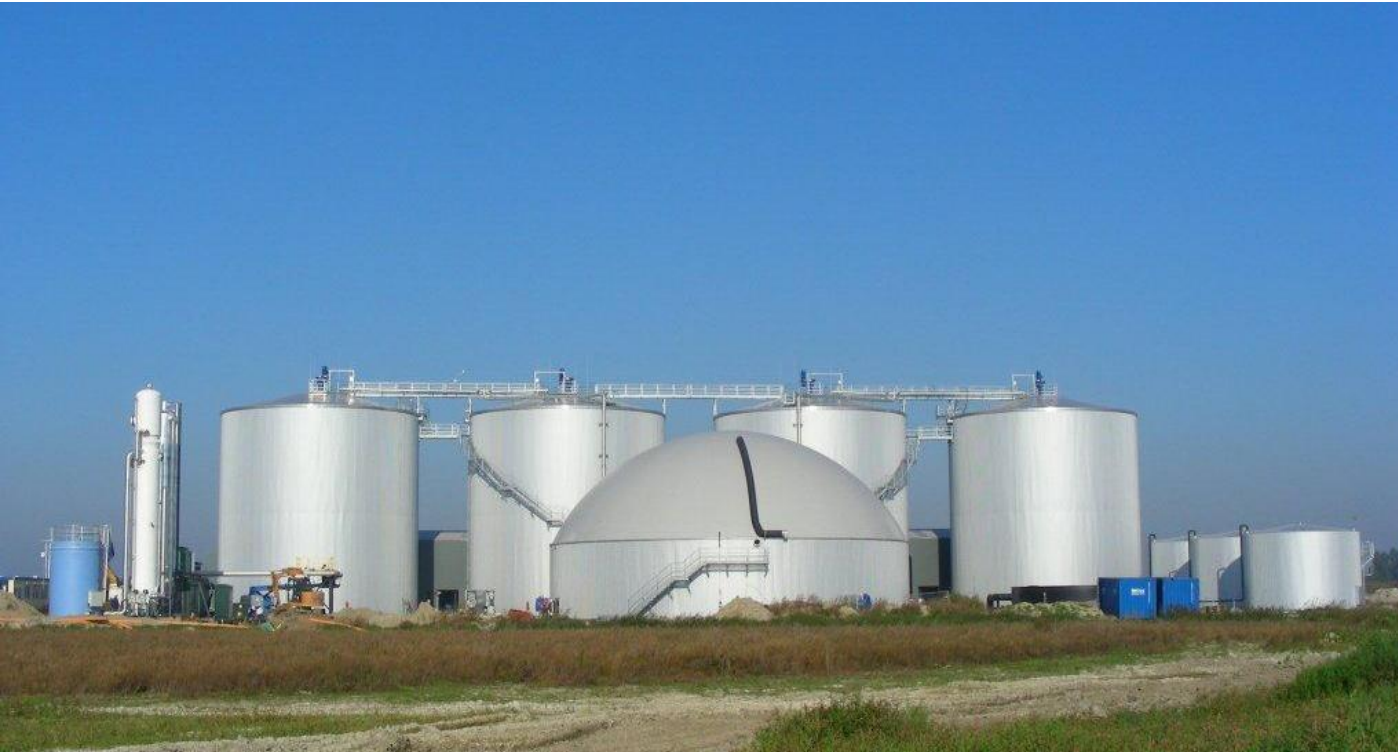
Dinteloord, The Netherlands

- Build: 2011
- Substrate: sugar beet ends, sugar beet leafs, sugar beet, vegetable waste 114,000 t/a
- Digester: 4 x 4,480 m³ steel tank
- Upgrading of 1,750 m³/h biogas to 990 m³/h methane
- Gas holder above secondary digester
- Treatment of digestate with decanter

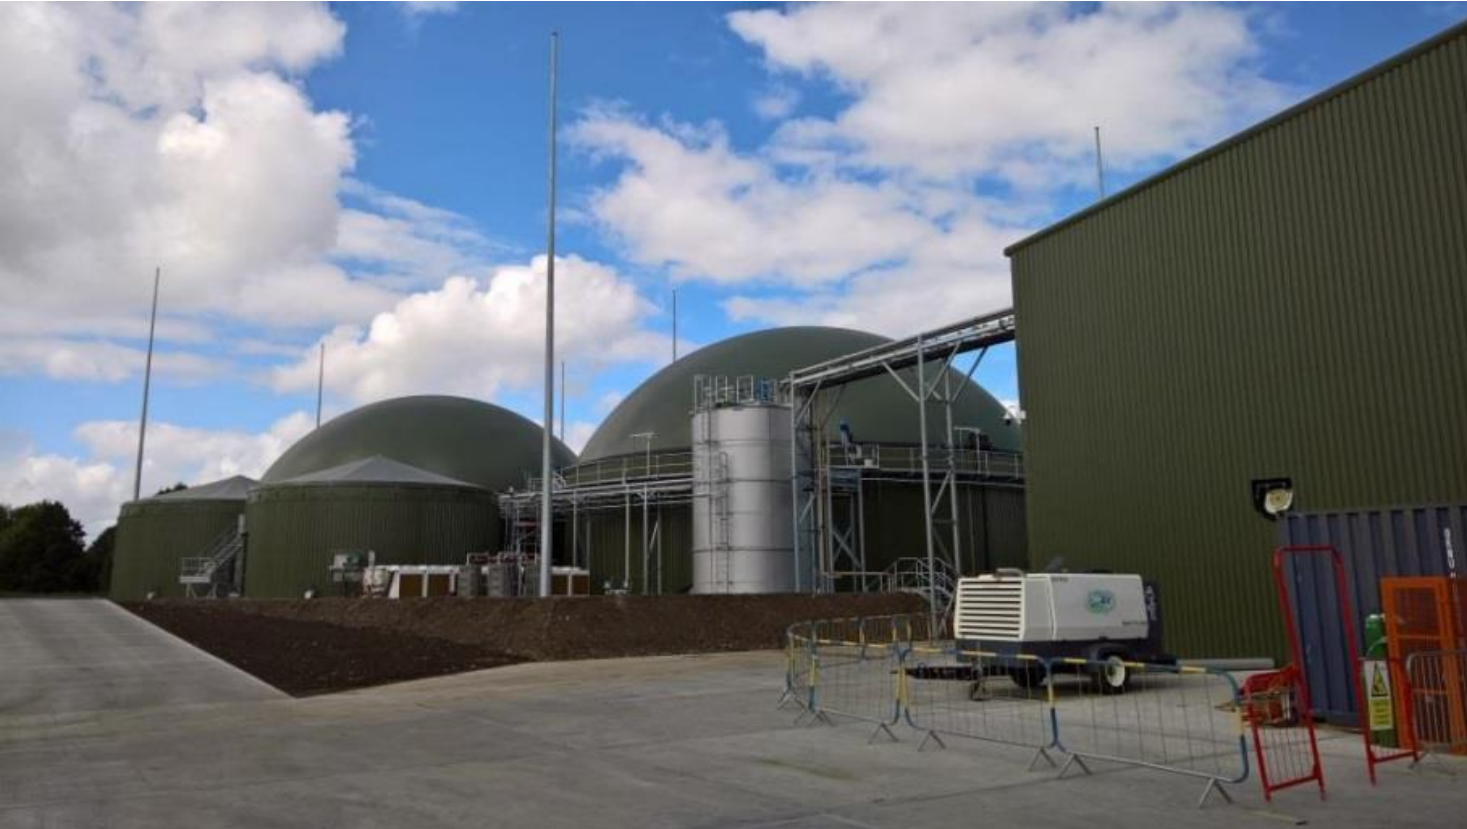
Derby, United Kingdom

- Built: 2017/18
- Substrate: Food waste
- Digester: 2 x 5.000 m³ concrete tanks with gas holder roof
- Secondary digester: 4.500 m³ concrete tank with gas holder roof
- Upgrading of biogas
- Mesophilic operation
- Reception of hot substrate

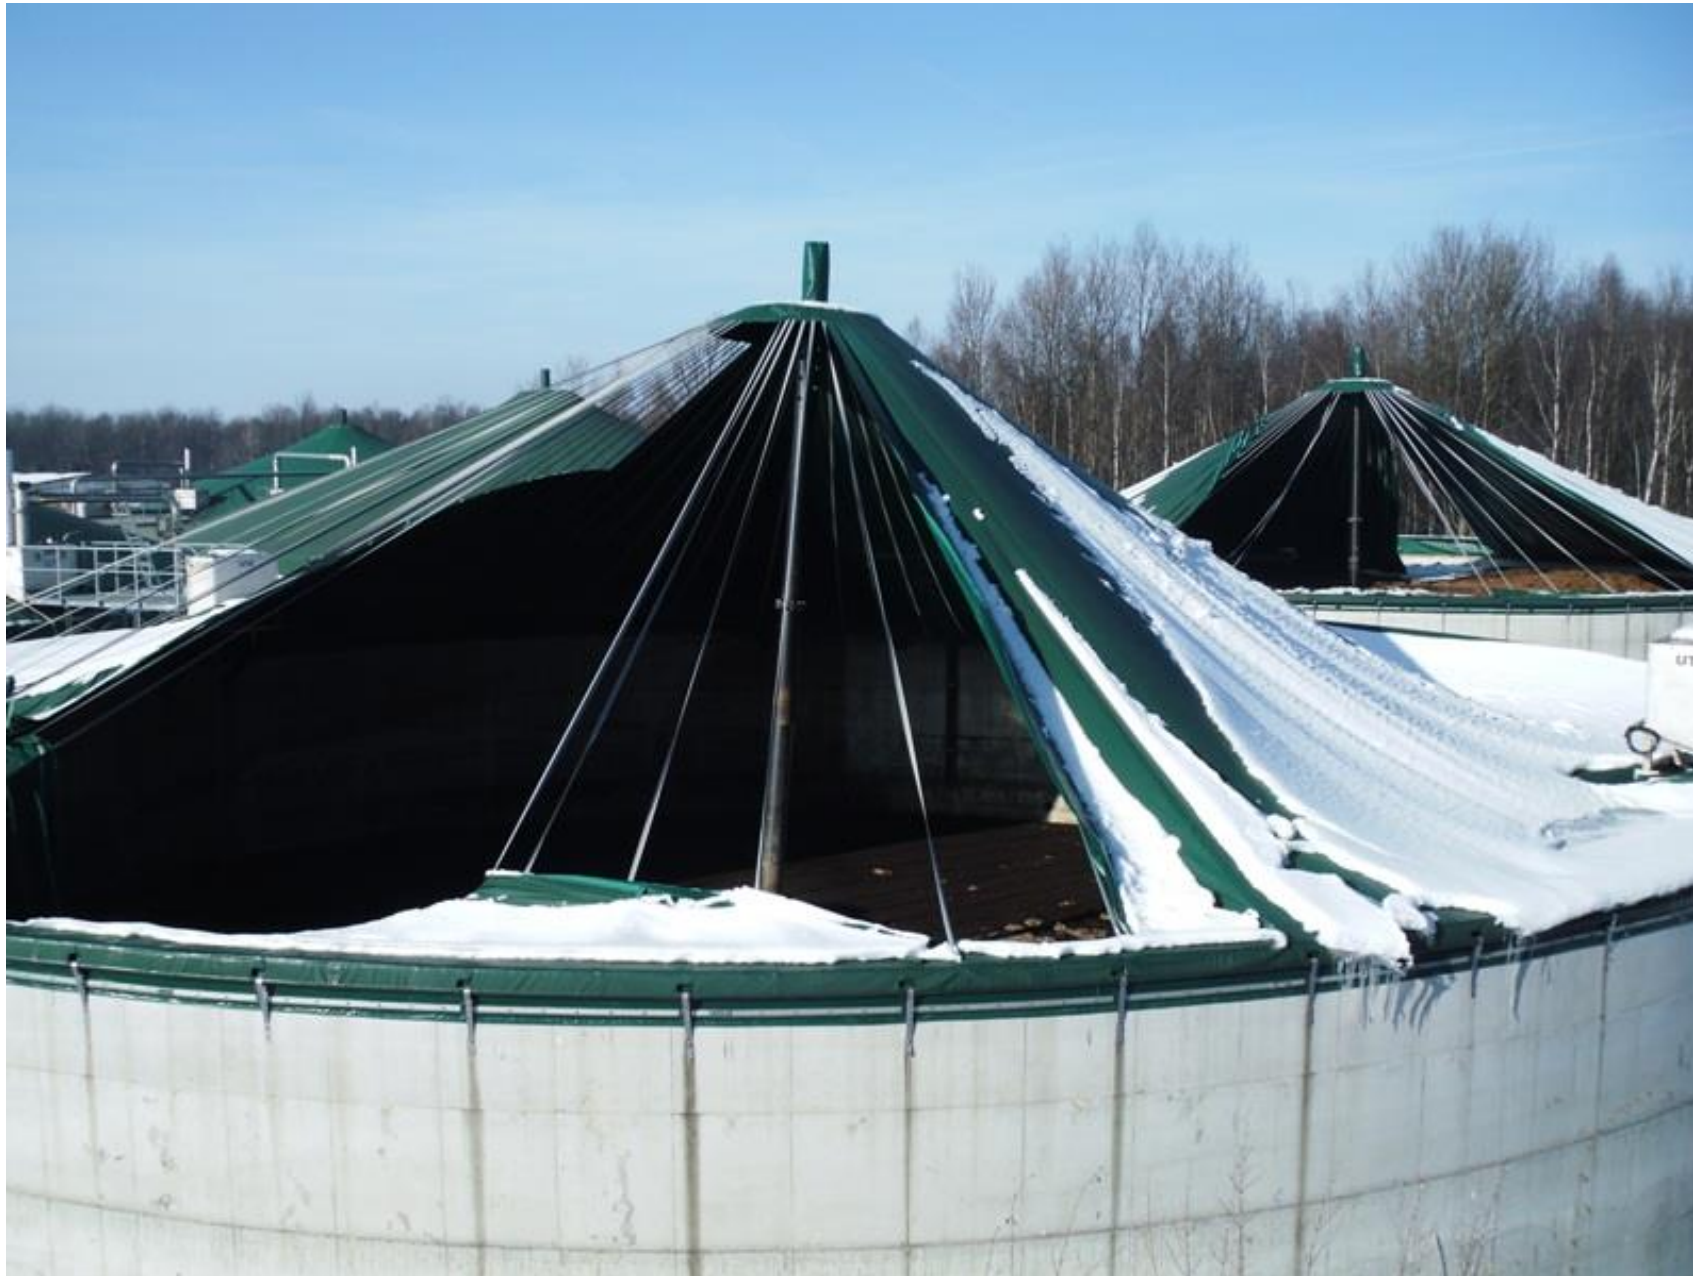
1783

2010
 Insurance Case
 Design: Gastight single membrane
 Cover on Storage Tank for Digestate:
 2.5 mbar
 Real life: no gastight construction
 Identical damage on two tanks
 Tank Diameters: both 29 m
 Both center columns deflected
 Heavy Snowload

High snowload in combination with
 wrong snowload assumptions led to
 collapse of both roofs

About € 100,000.-

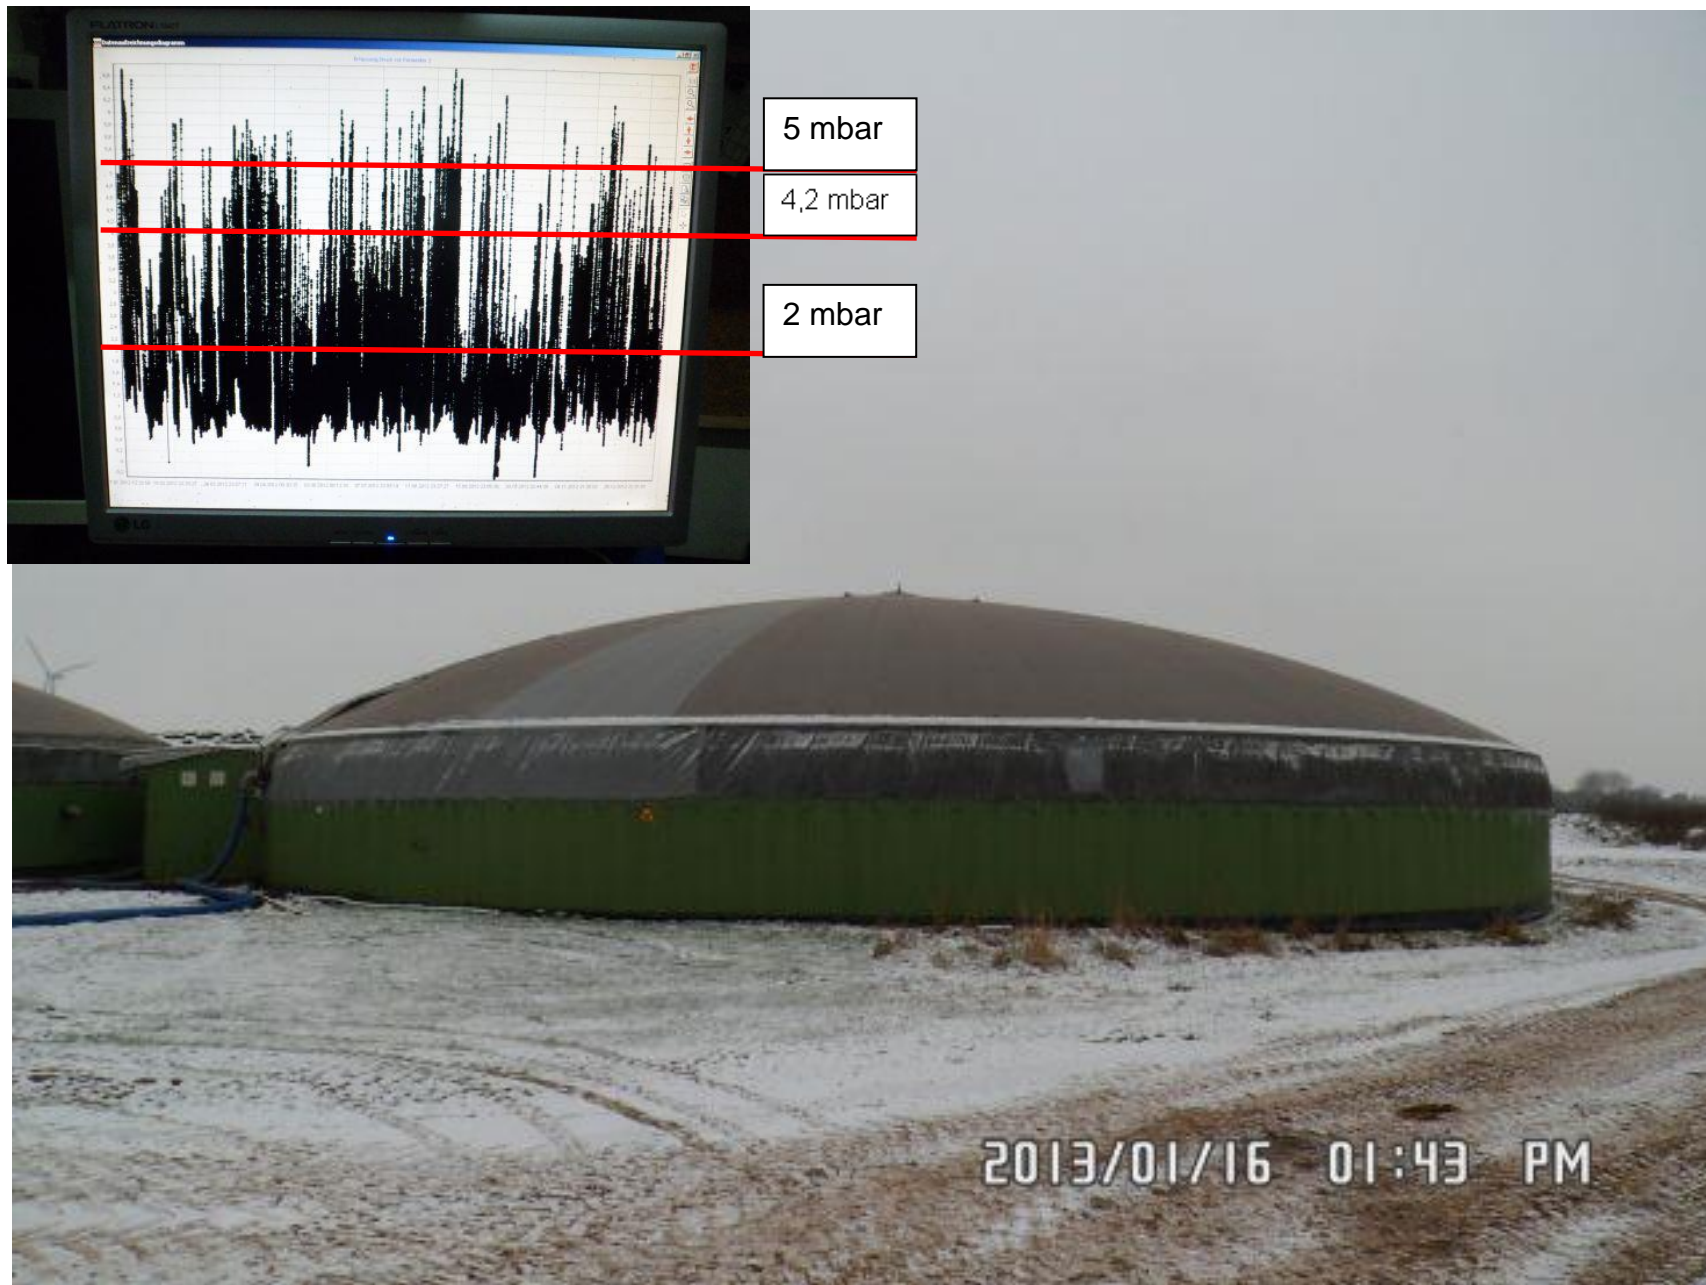
2084

2012
Court Case
Gastight double membrane Cover on
Secondary Digester Tank: 2 mbar
Tank Diameter: 26 m
No evidence about proper installation
nor function of PRV at all. No
maintenance.

Too high operational pressure
Cracking of outer membrane over a
longer period

- Center Column:
- 6,0 m concrete
 - 0.55 cm foundation
 - 1.40 m stainless steel on top

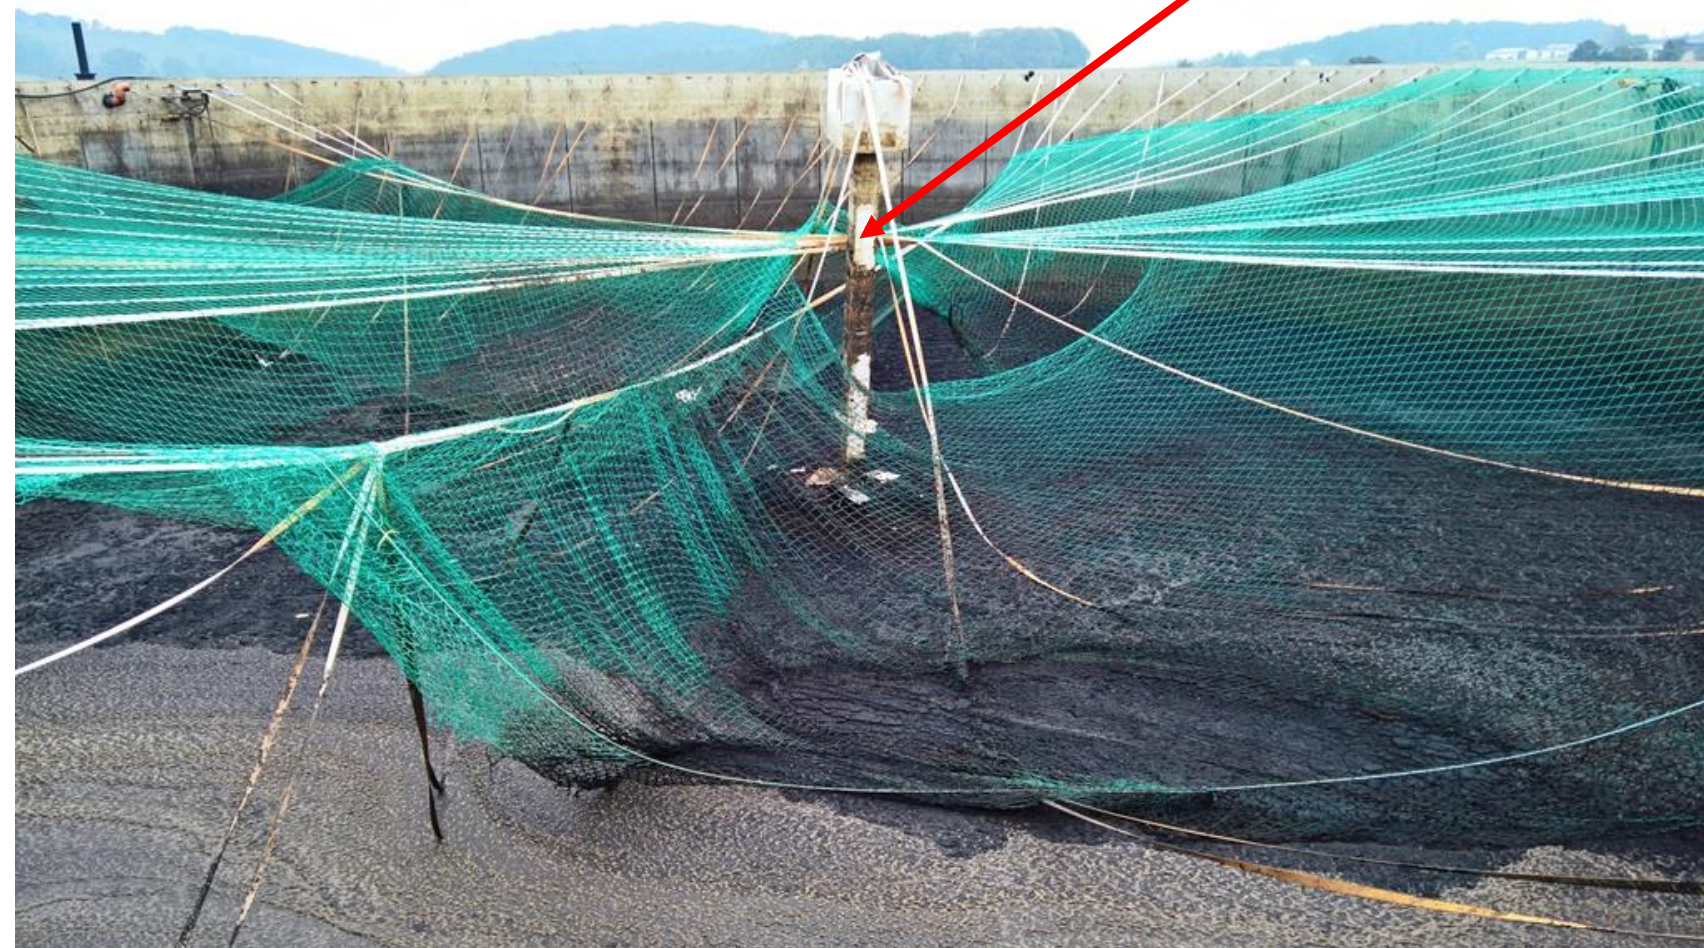
B2595

Tank Diameter: 34 m

Originally: gastight single membrane gas holder roof

New: Gastight double membrane Cover on Storage Tank for Digestate

Begin Damage between April 2013 and March 2016 / final damage summer 2016

No definition of „normal operation“

No test run

Unclear layout PRV (pressure, flowrates)

Never observed that inner membrane „went up“

No pressure control

No pressure calculation of gas system

No commissioning

Poor documentation

About € 100,000.-

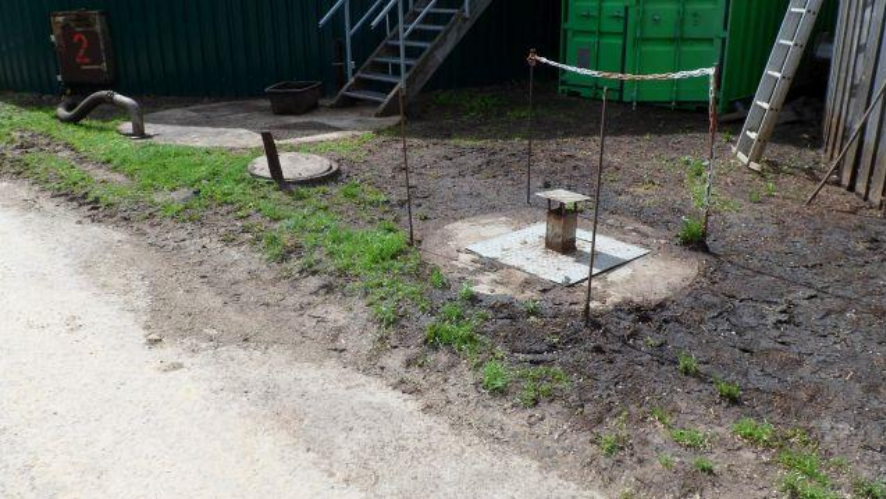
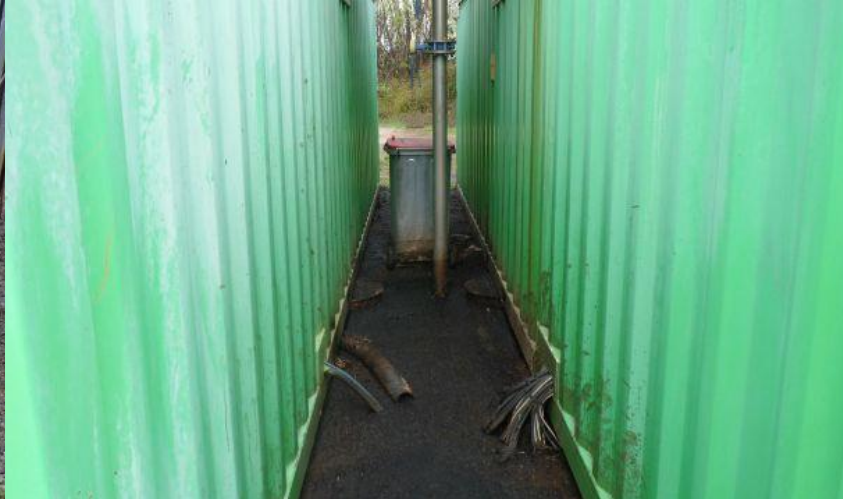
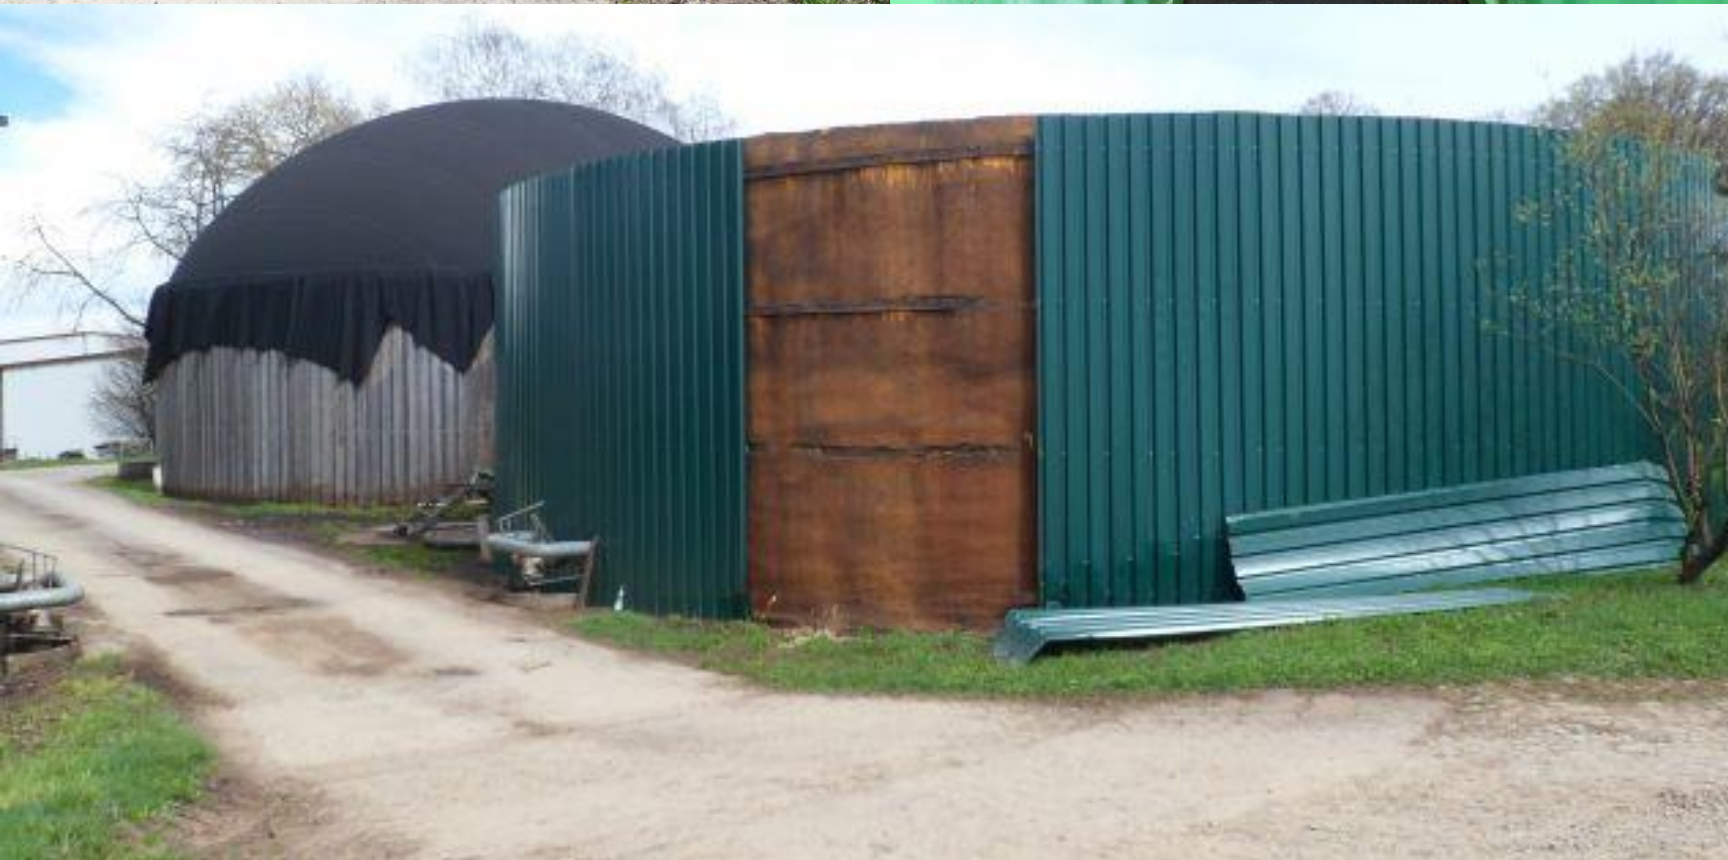
2018
Insurance Case
Small Biogas Plant built in 2006
Design: Gastight single membrane
Cover on Digester and Secondary
Digester Tanks
Pump between both tanks fed
Secondary Digester Tank until single
gas holder membrane was destroyed.
Eruption of manure/corn silage mixture
into the environment

Manual operation, not automatic. No
proper safety control nor hazard
assessment

About € 25,000.-

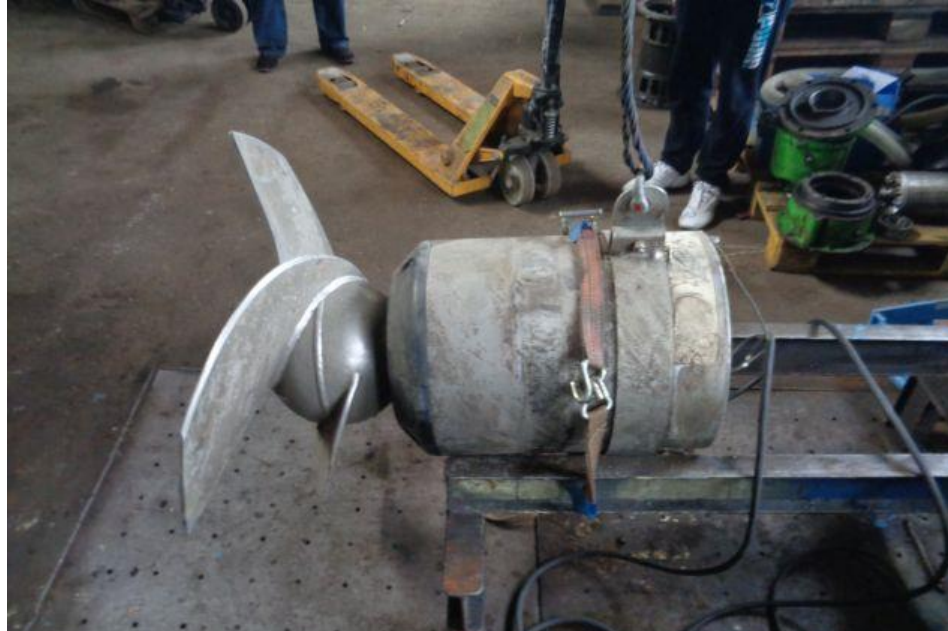
2287

2014
Court Case
Design: submerged mixer
Failure because of not properly fixed
electrical cable at the wooden beams of
the roof construction

Poor supervision of construction

2014
 Insurance Case
 Design: side-mounted mixer
 Broken shaft because of not properly
 installed lower bearing/shaft + poor
 material quality.

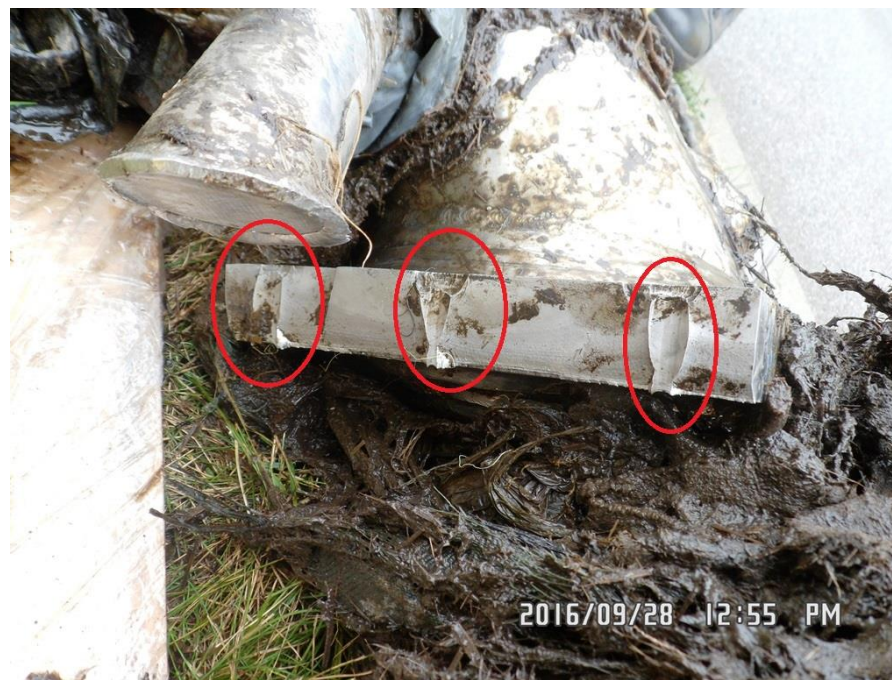
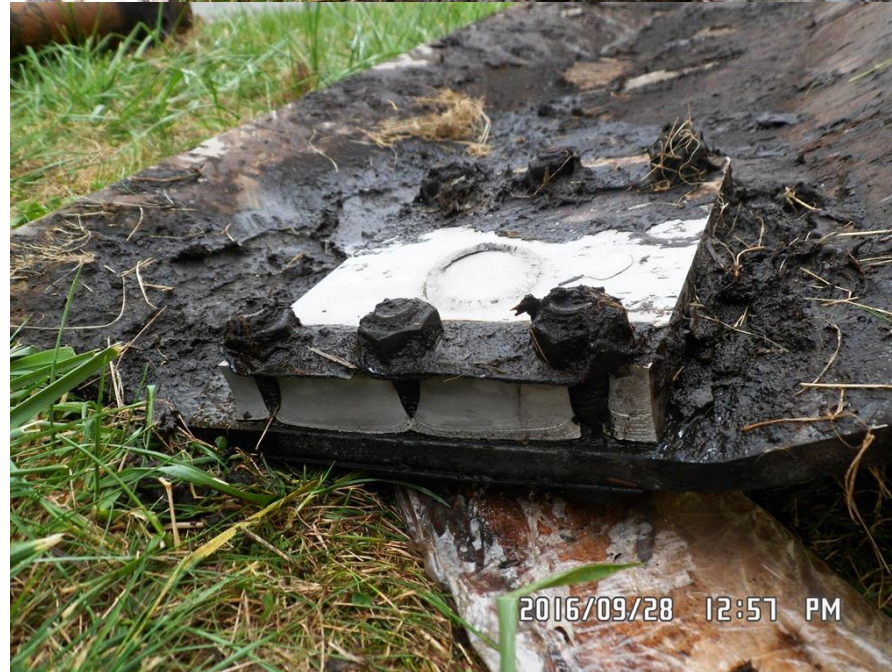
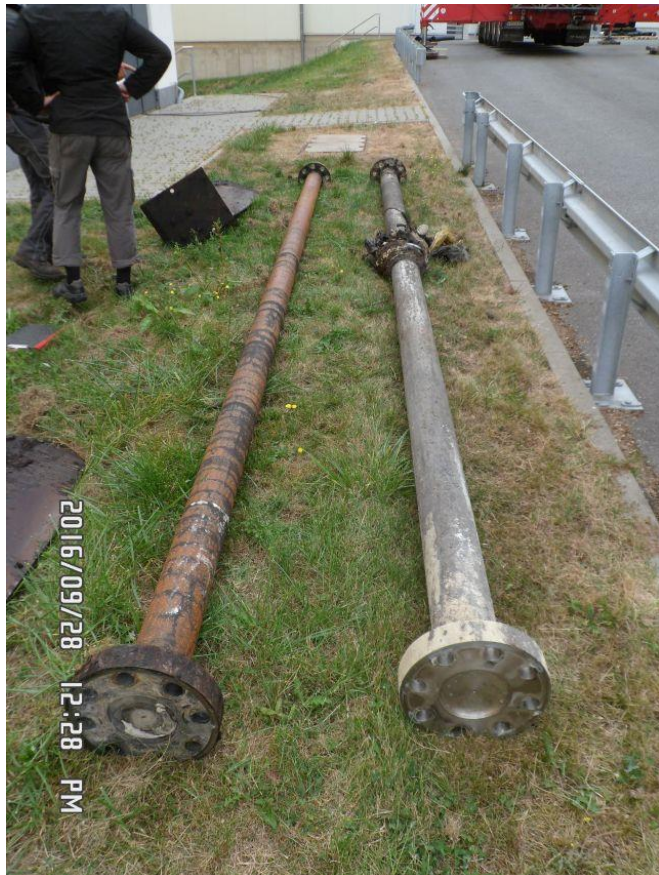
2552

2016
Insurance Case
Design: top-mounted mixer
4 high digester/secondary digester tanks
In 3 out of 4 tanks the blades were broken off the shaft

Poor welding of the stiffener construction
Fatigue break of blades

- Proper supervision of construction, test-runs, final commissioning is of utmost importance.
- In case there are several mixers in one tank – those mixers have to fit together (horizontal & vertical forces and moments) in order to have a long-term solution and not an overload of one/some of the mixers involved.
- Mixers should be designed for a certain input substrate. With the change of the input substrate mixers may have to be re-calculated.
- Mixers are not only good for substrate mixing but also for other jobs such as distribution of heat in the digester tank, easing the rise of biogas bubbles (“increase” buoyancy), etc.
